# Idaho Completion Project

ICP/CON-05-00750  
PREPRINT

## Utilizing Divers In Support Of Spent Fuel Basin Closure Subproject

2005 International ALARA Symposium

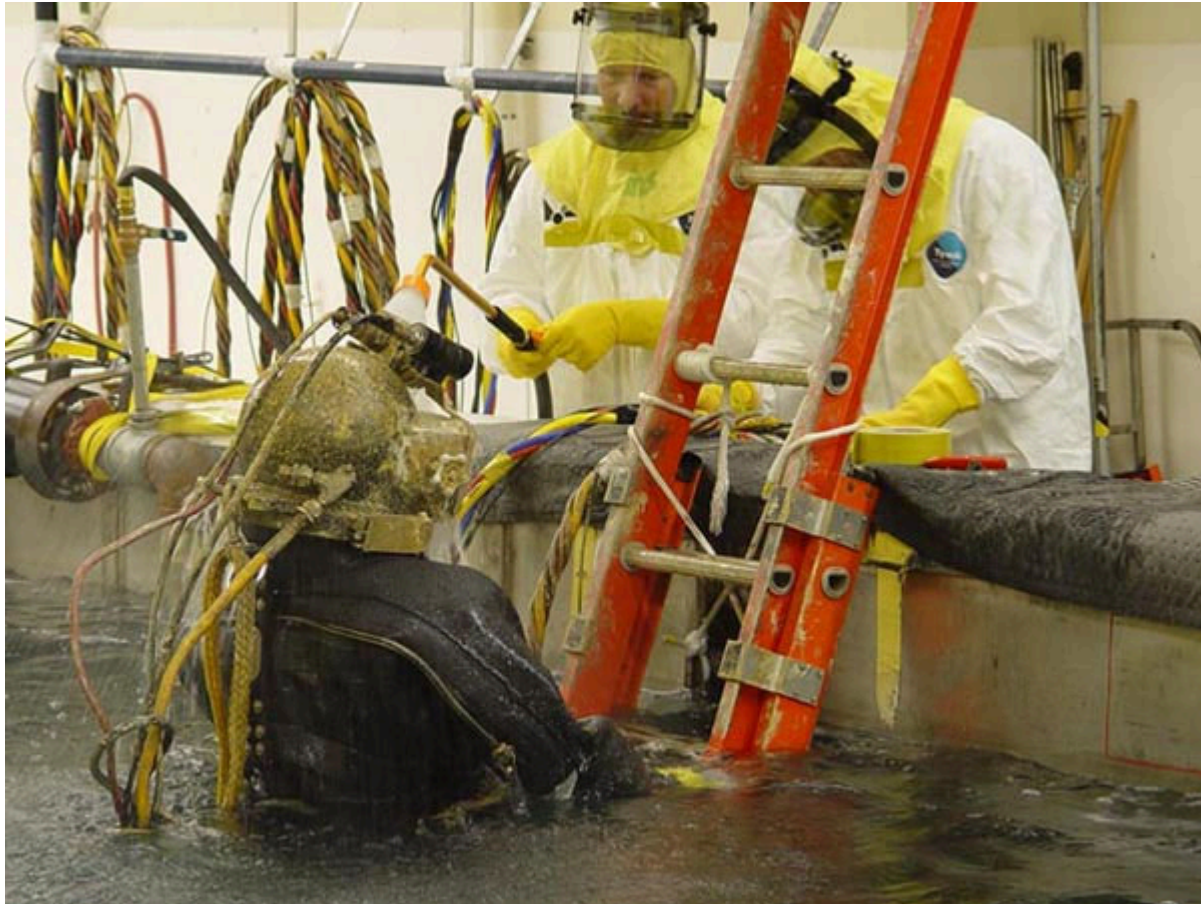
**Dive tenders spray a diver as he emerges from the water for contamination control.**

- A splash curtain was installed along the entire length of the tenders' work area.
- Divers were instructed to remain still with arms outstretched while the suit was completely dried.
- Tenders were instructed not to get underneath the diver's arms to avoid dripping water.

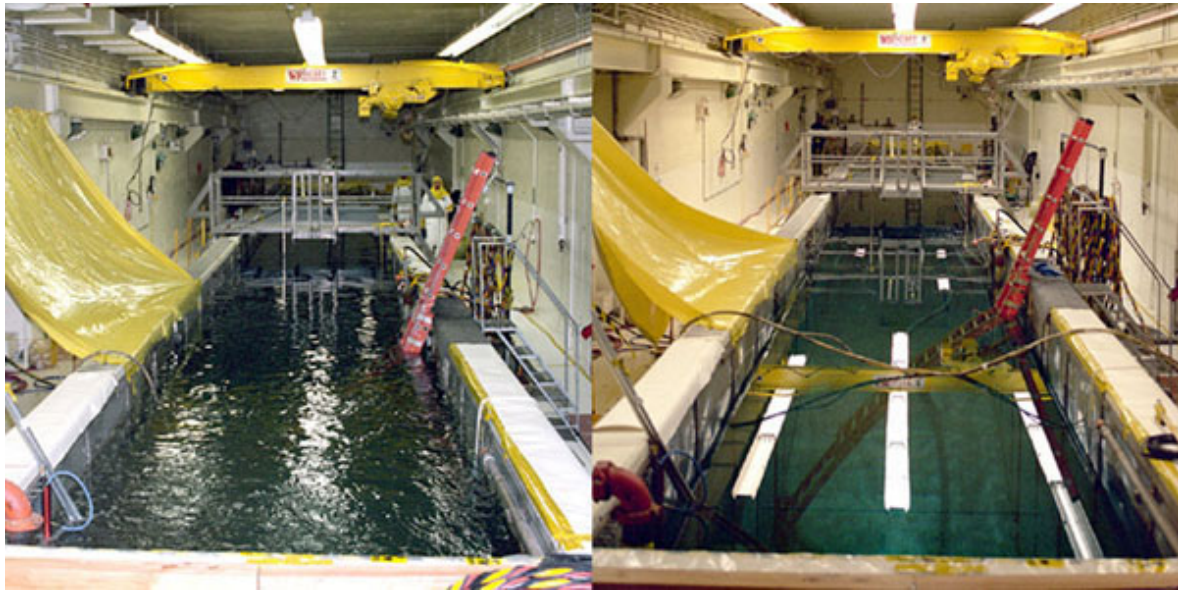
**The MTR canal before and during cleaning.**

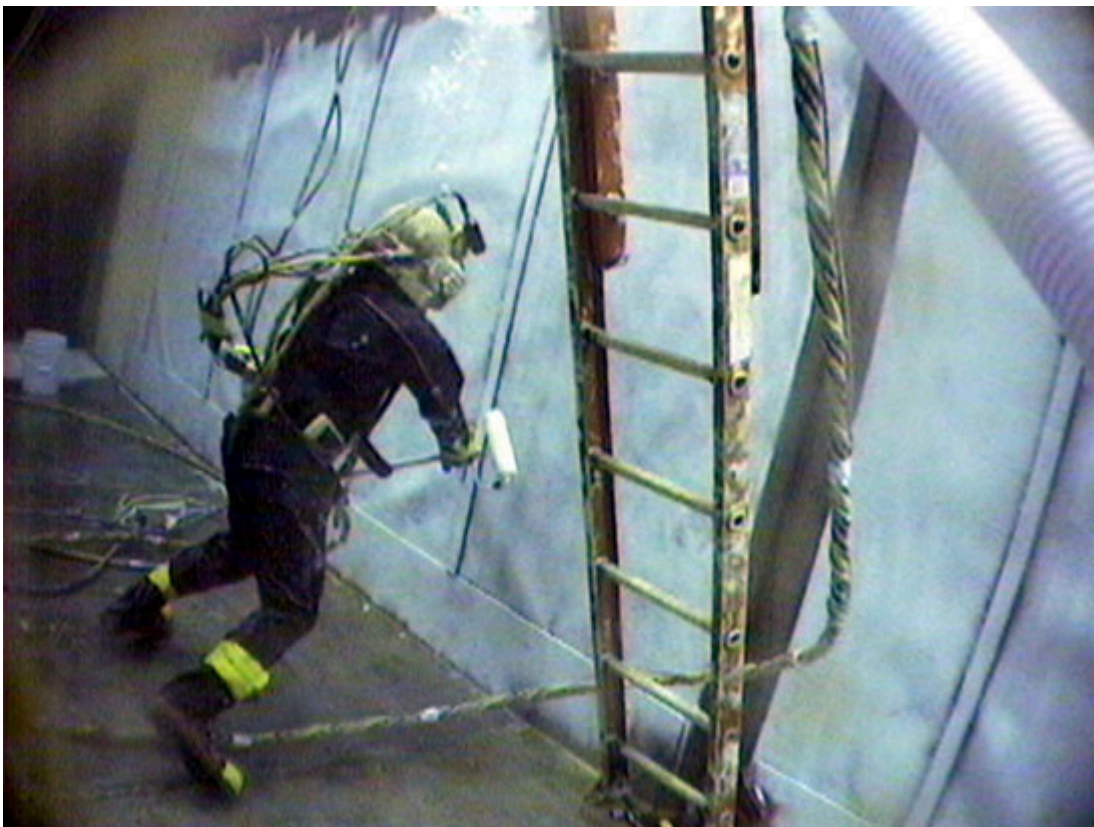
It turned out some expectations about fixative application were not met. The epoxy coating is much more difficult to apply under water than house paint in air. It took considerable effort to get a complete coating that passed the dive master's inspection. The condition of the existing surfaces directly effects the time needed to apply the fixative. At TAN, the divers also had to deal with the bubbled and loose paint layer on the basin walls. The basin walls at INTEC were even more deteriorated than at TAN. The roller was not effective there, so fixative had to be applied by hand. Fixative application at MTR and PBF went smoother with the steel-lined basins.

Applying fixative to the wall of the MTR canal.

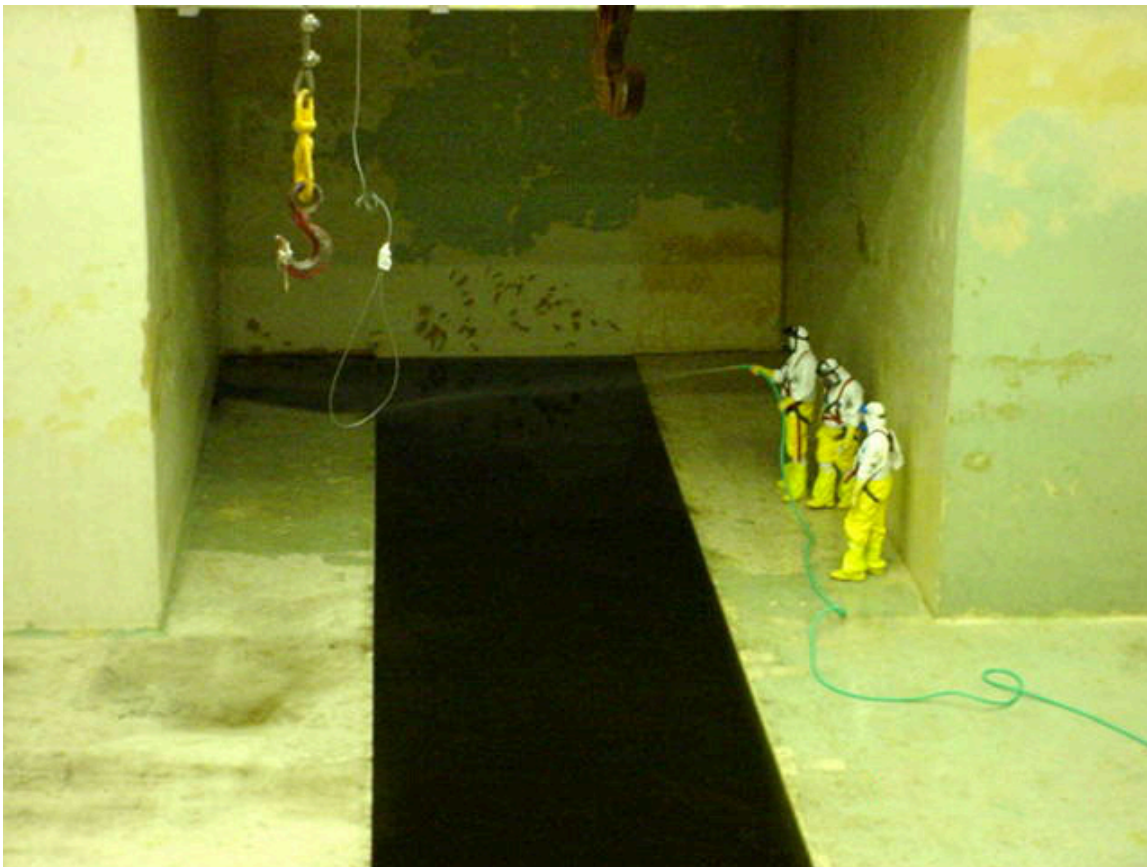
**Workers rinse down the basin floor at TAN as the last of the water is pumped out of the transfer cart trench.**

After water was removed from the basin at TAN and MTR, a final rinse-down of the walls and floor, as well as using large squeegee tools, helped get as much water out of the basins as possible while keeping contamination spread to a minimum.

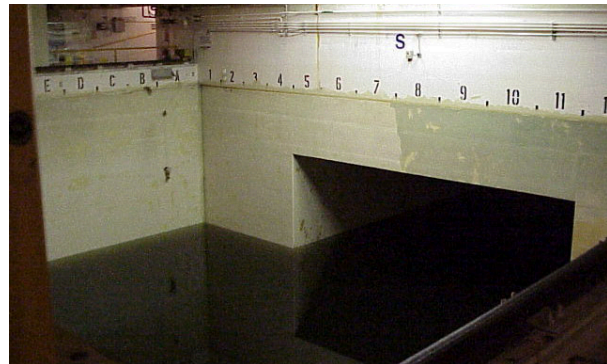
Applying calcium hypochlorite to maintain the water quality to the water in the TAN basin produced an unanticipated side effect – it turned the water a dark brown color. The color change was due to chlorine in the additive causing metals in the water to precipitate out. Although it didn't hamper the work significantly, the sudden color change was a dramatic difference from the nearly crystal-clear appearance of the basin water after sludge removal was completed.

Water removal under way (Water darkened by calcium hypochlorite)
